## Natural Water Retention Measures

# *Case Study*

## *Floodplain restoration of the river Slampe, Latvia*

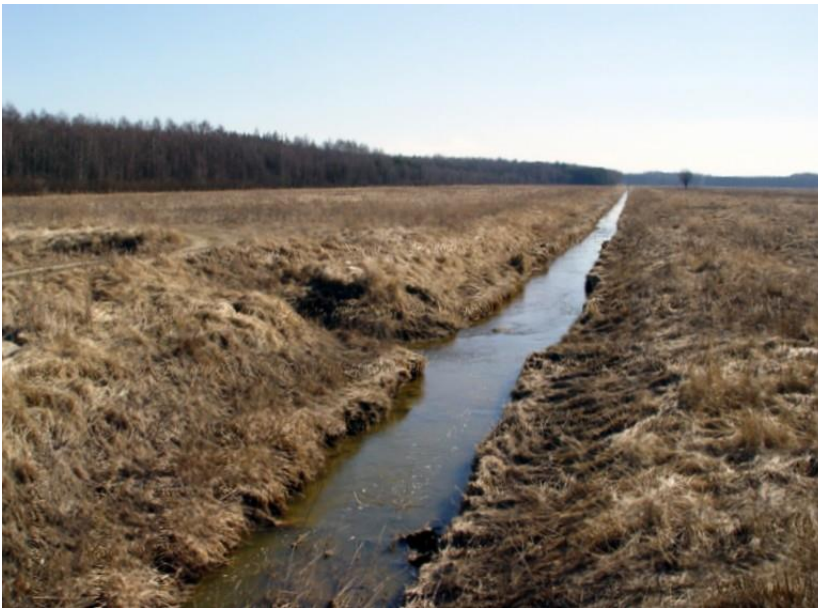
**Figure 1** The river Slampe, before implementation of restoration measures in 2003 (Author Gatis Pavils)

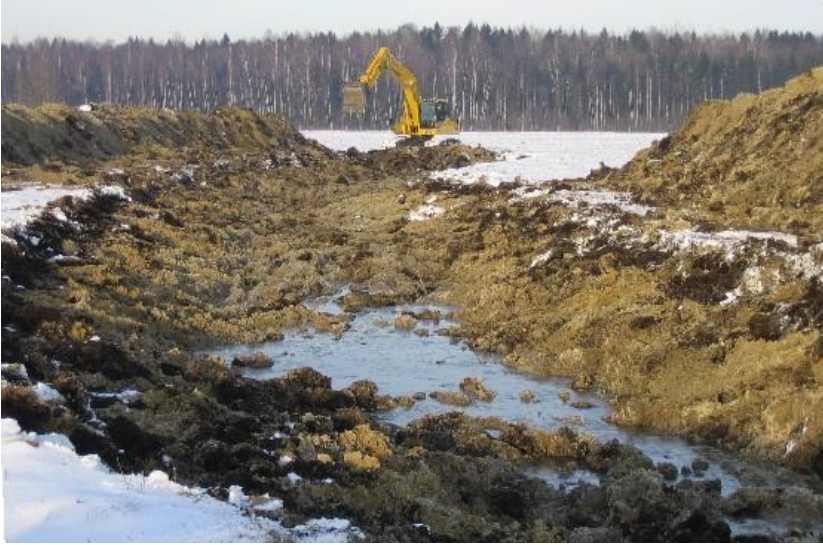
**Figure 2** The re-meandering of the river bed of the river Slampe in 2005 (author Andis Liepa)

Project scale	Small (e.g. farm, plot, building complex, block)	<i>2.1 km long stretch of the channeled river was turned in to 4.6 km long meandered stream. Natural floodplain grasslands resorted in 105 ha</i>
Time frame	Date of installation/construction (MM.YYYY)	<i>01-05.2005. In total 5 month</i>
	Expected average lifespan (life expectancy) of the application in years	<i>Not relevant</i>
Responsible authority and other stakeholders involved	<i>Name of responsible authority/ stakeholder</i>	<i>Role, responsibilities</i>
	1. Ķemeri National Park	Project manager and land manager
	2. Meliorprojekts Ltd	Elaboration of technical project, supervision of the

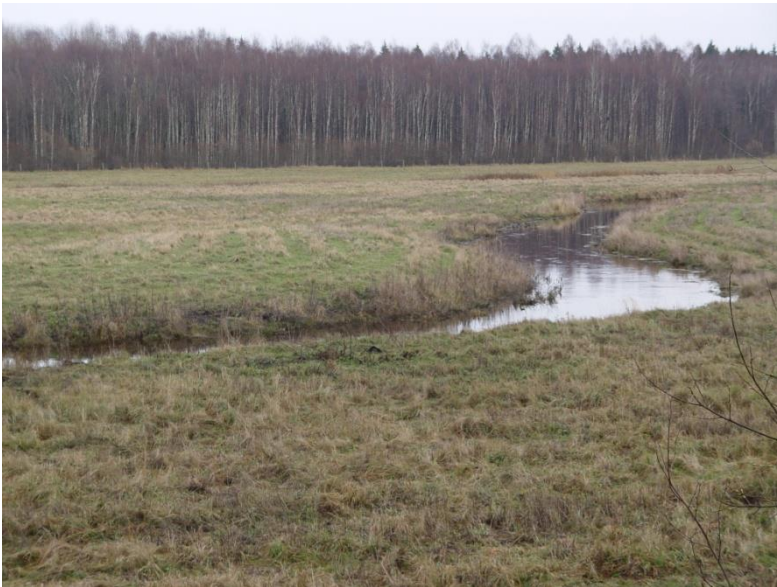
**Figure 3** The river Slampe after restoration (author Janis Kuze)

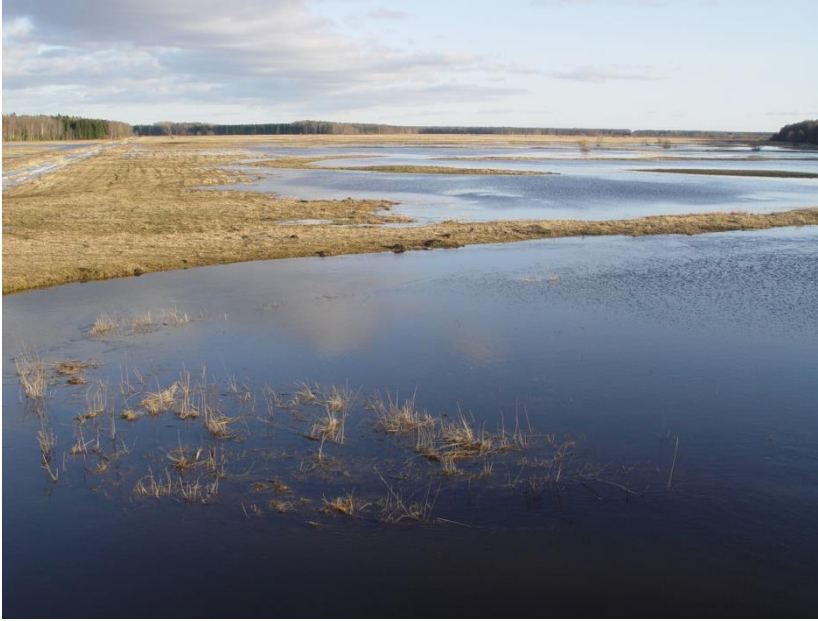
**Figure 4** The river Slampe during snow melts in spring (author Janis Kuze)

Mitigation of other biophysical impacts in relation to other EU Directives (e.g. Habitats, UWWT, etc.)	<i>150 ha of restored floodplain meadows. 30 % of restored meadows were flooded by first spring floods, but flooded area depends from the floods volume</i>	<i>ha</i>	<i>105</i>
Soil Quality Improvements	<i>Data are not available</i>	-	-
Other	<i>Data are not available</i>	-	-
