## Natural Water Retention Measures

# Case Study

## *Ciobarciu wetland restoration*

## CS: Ciobarciu wetland restoration, Romania

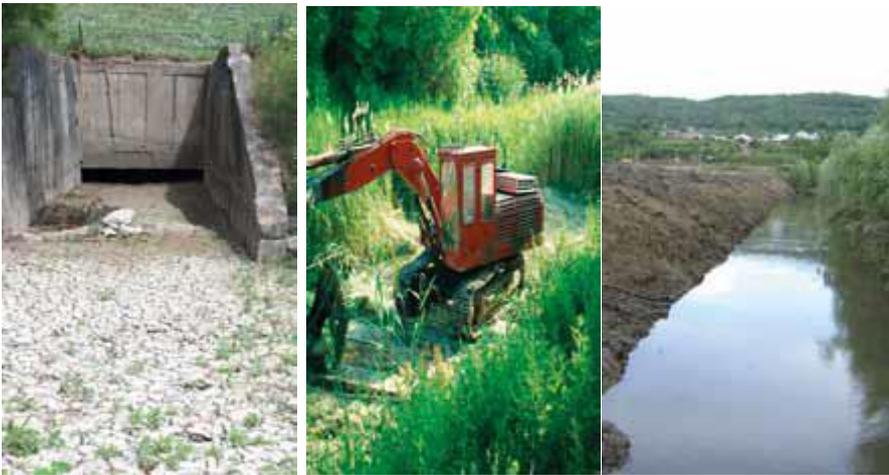
**Restoring flow on the Old Jijia river (from left; before, during and after work)**

<p>course was deviated by digging a channel to the Prut at Chiperești. The last 56 km of the Jijia River (<b>Old Jijia</b>), which is parallel to the Prut, has been cut-off and it can be supplied with water from the Jijia by the hydrotechnical knot at Chiperești when needed. Otherwise, the old Jijia is only supplied from its own river basin by four small tributaries with intermittent flow. In the floodplain an irrigation and drainage system has been developed, which, however, was never finished completely. In the same area two fishing ponds were built which now have been abandoned for financial reasons (Osoi and Gorban fishing ponds). The land from the floodplain was intensively used as cropland. Starting with the political changes from 1989, the agricultural activity in this area has been reduced pastures took the place of the crops. The irrigation system was no longer in use and the drainage system worked only partially. Agriculture in this former wetland area now suffers from lack of water and locally the soil is getting brackish</p>
